---TECHNICAL REPORT---

No. 13755

Test and Evaluation of the
LMTV Driveline
1998

By Stephen J. Aamodt

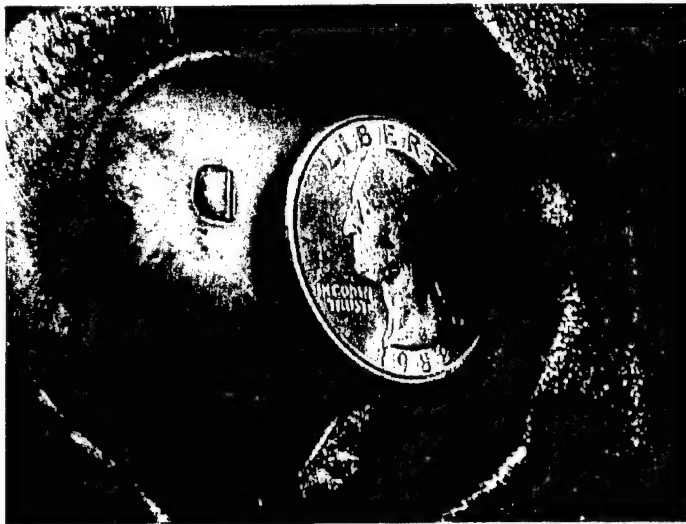
Figure 6 – Play Between the End Cap and Yoke

Once these items were replaced, testing began again only to notice immediately that the rear driveshaft was wobbling. One end cap on the transfer case u-joint had overheated and seized up. Inspection revealed that this failure was typical of those witnessed in the field. It is suspected that the reason this was not noticed before was do in part to thermal expansion that, when the end cap failed, caused the u-joint to be held relatively in place until it cooled off. While the shaft may not have been displaying wobbling that could be visually seen, it was likely causing excessive vibration throughout the rest of the system. It is probable that this extra vibration helped cause the premature failure of the water pump.

The wobbling itself was being caused by the space created between the end cap and the yoke. From figure 6, the amount of play that was discovered was such that a quarter would easily fit in this space. Also visible is the scoring in the metal, caused when the cap overheated, and a slight bulge in the center of the cap. Though some needles were found that were a little squished, nothing was wedged underneath the cap. The space between the yoke and end cap allowed the driveshaft to shift off center which, when spinning, displayed the wobbling motion. This failure occurred while using the Joint Clutch & Gear straightened and balanced shaft. Later analysis of the shaft indicated that it had bent drastically when the failure occurred. Refer to Appendix B for the results.

At this point Joint Clutch & Gear sent a representative out to evaluate the cause of the failure on the driveshaft they had balanced and straightened. Upon inspection of the system, the representative stated that propshaft life cycle prediction with this arrangement was very difficult and failures could occur at any time. This was based on the angle of the shaft and the fact that the transfer case and axle are parallel to each other but have an opposite slope to that of the driveshaft. He also commented on whether a larger shaft was likely to solve the problem. He said that having a bigger shaft, to include a bigger and longer spline, may last somewhat longer but would eventually fail. He recommended tilting the transfer case to a flatter, if not opposite, slope. The axles should remain
